Work in the Old Smithville Burying Grounds for October 2012

Work In Old Smithville Burying Grounds – November 2012

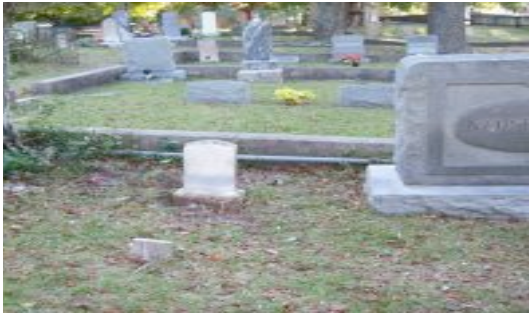
1. Lucy N stone at Northrop lot, Section BN, A-7: Base straighten, Stone adhered to base

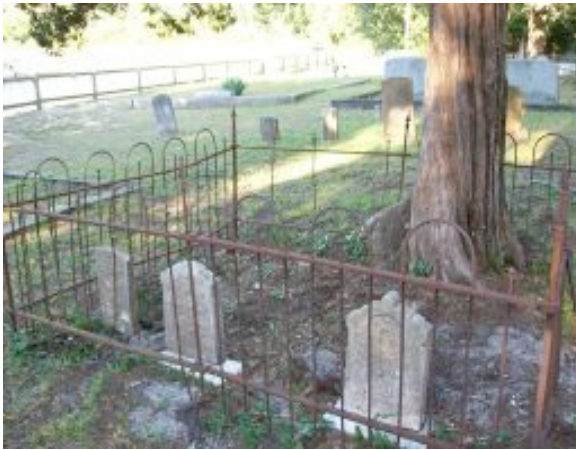
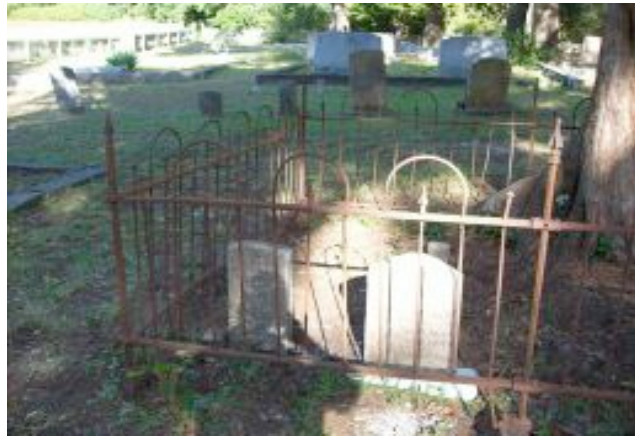
2. Ewell Lot, Section BN, B-6: Fence added to from pieces of another broken fence, small stone set up vertical.

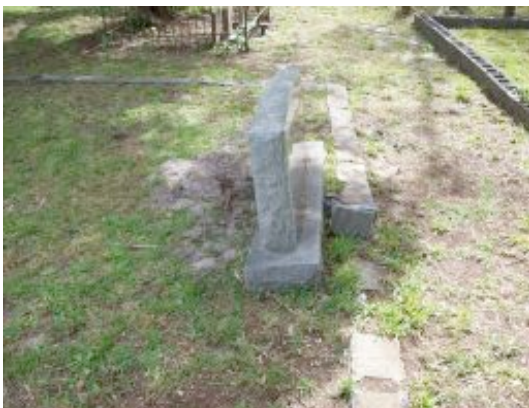
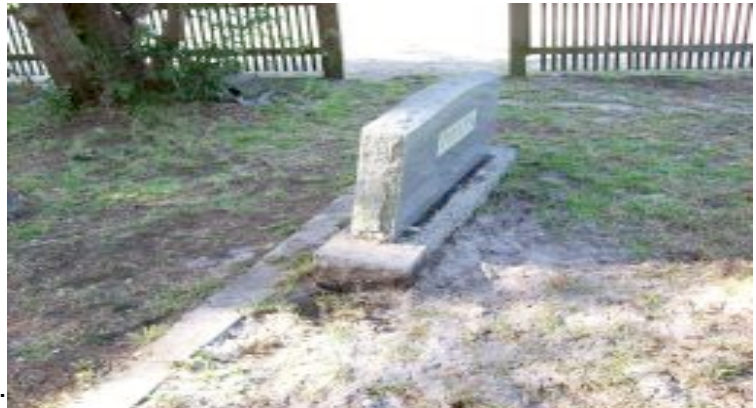
3. Phelps family name stone, Section BN, A-6: Base lifted, big stone moved toward back.

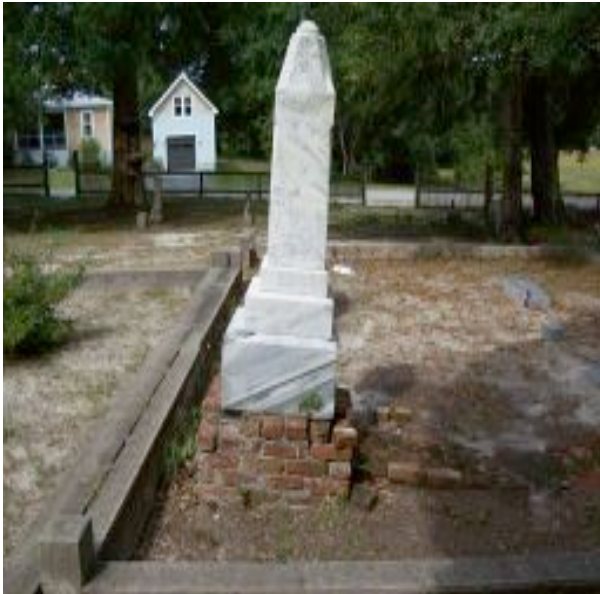
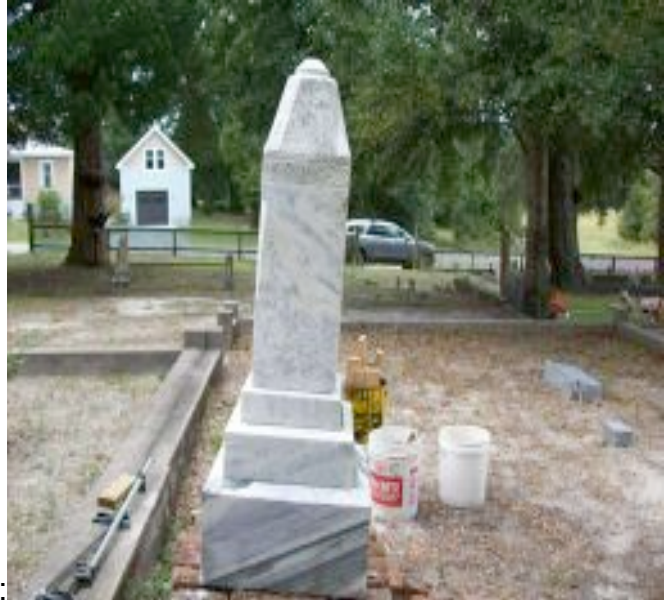
4. Bryan Morse stone, Section NR, E-4: Big white land mark marker made out of several stones. Tried to straighten it, but pedestal under is made out of bricks that are no longer cemented together. Was able to move the upper stones back from their edge. Was able to place some small pieces of wood under it, but it needs more work than I can give it.

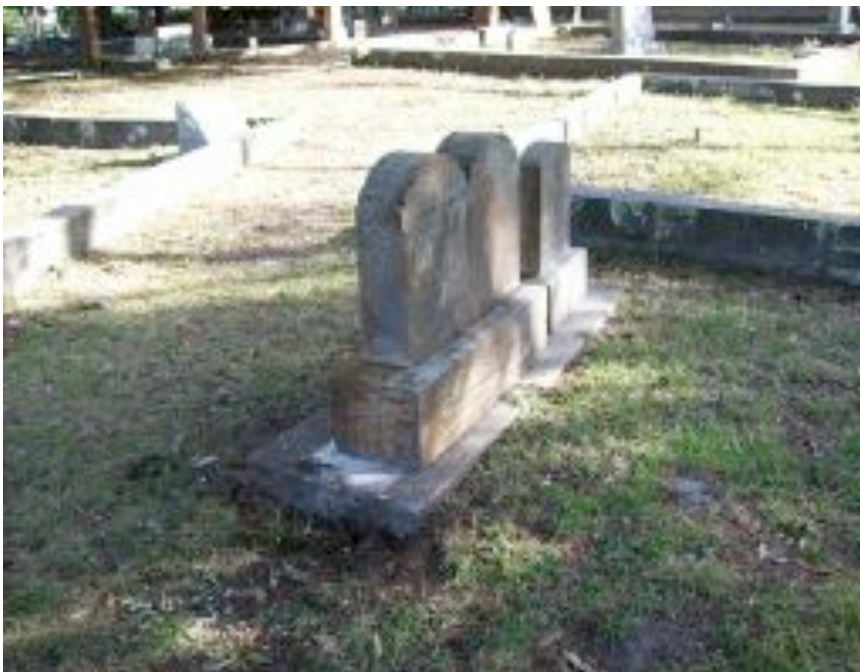
5. Peadrick Stones, Section BN, B-6: Fixed the Alice K one where it rocked back and forth (smaller one). Put stones under the larger stone to the left where the base had sunk and the stones on top were moving toward the ground.

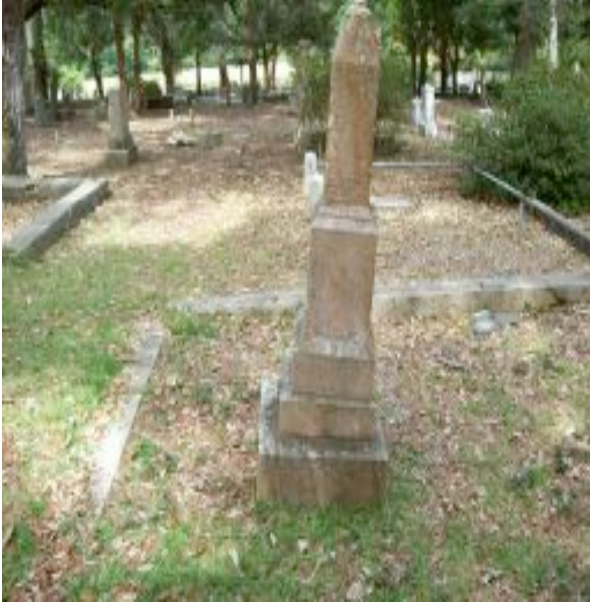
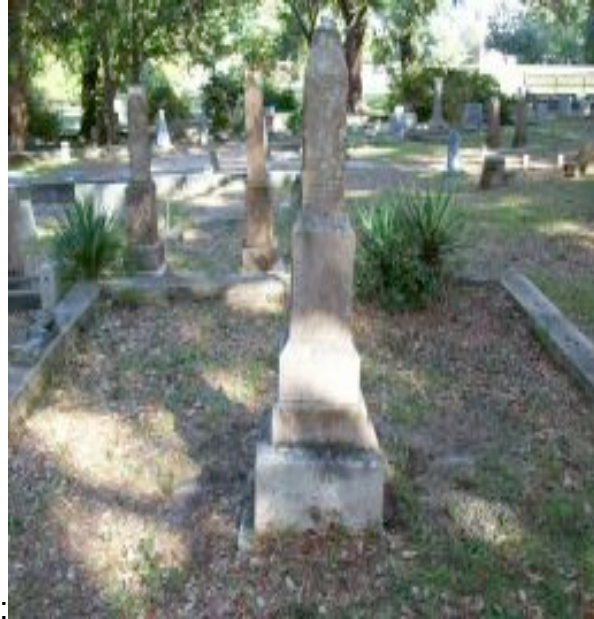
6. Martha Hood stone, Section BM, E-7: Leading badly, big, and made of several smaller stones. Moved smaller stones away from the lower side. Tried to get under it, but foundation goes down to the crypt and I can't be certain that the jack I use will not go into the crypt. Need professional help.

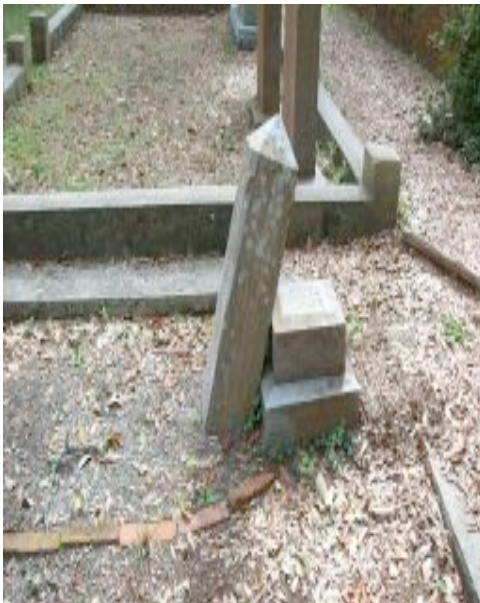
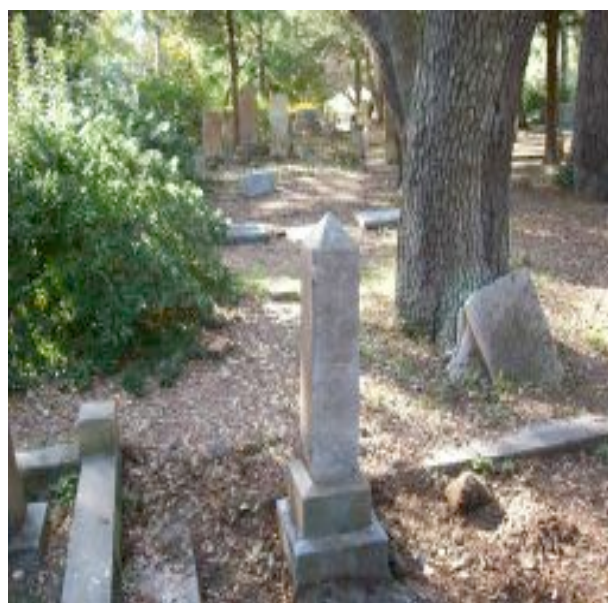
7. Mary Susan Potter –Section BM, F-8: Put stones under the base leveling it, put top obelisk back on base.

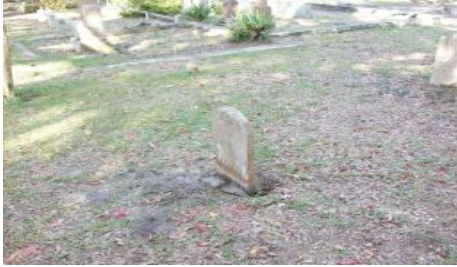
8. Capt Andren Currick – Section BM, F-8: Straighten.

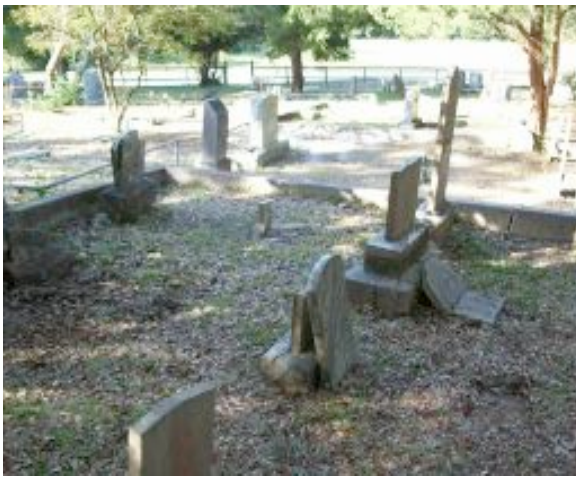
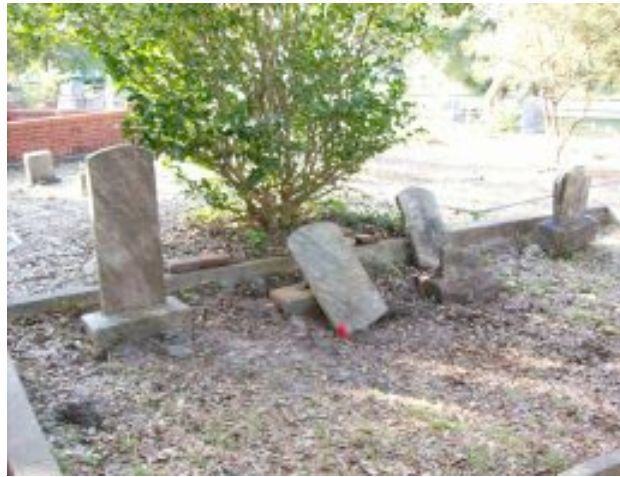
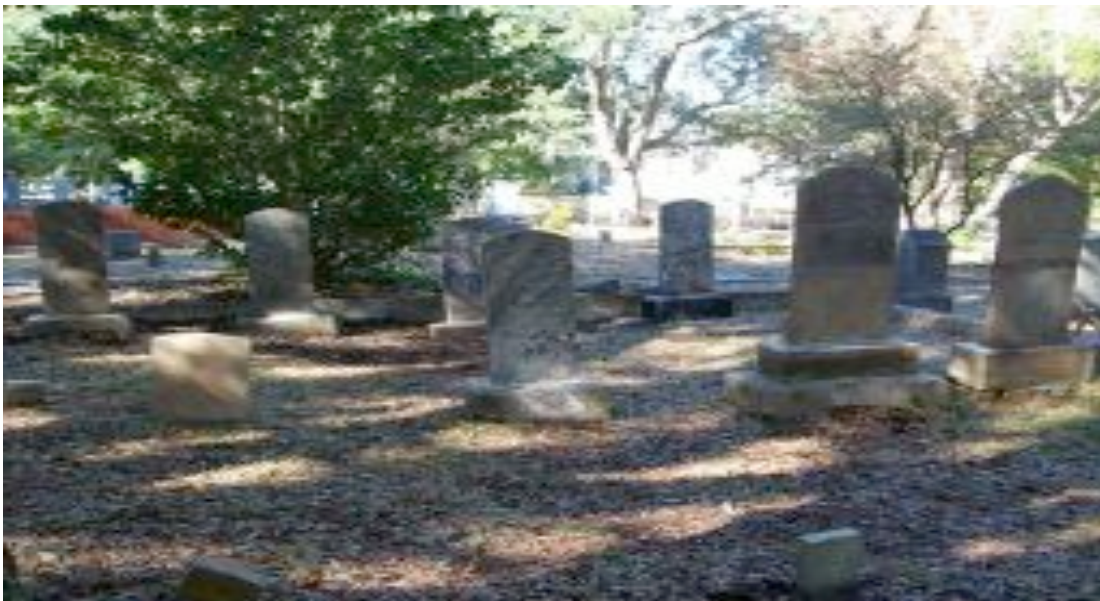
9. Price/Swan Lot – Section BN, G-6: Put stones under 5 bases, epoxied 2 bases, epoxied 5 different head stones. relocated 3 foot stones.

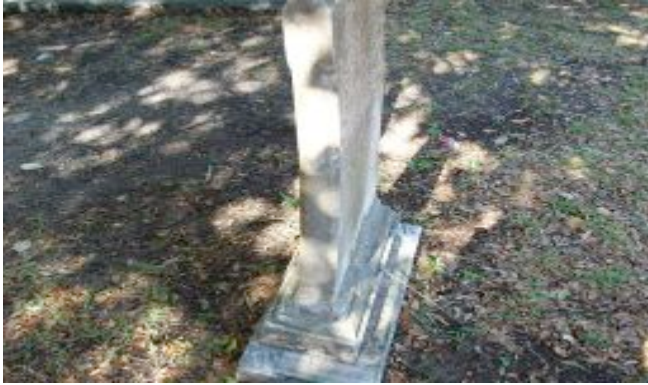
10. Thomas G. Drew stone Section NR, F-3: Moved stones back toward the back to keep stone from falling forward.

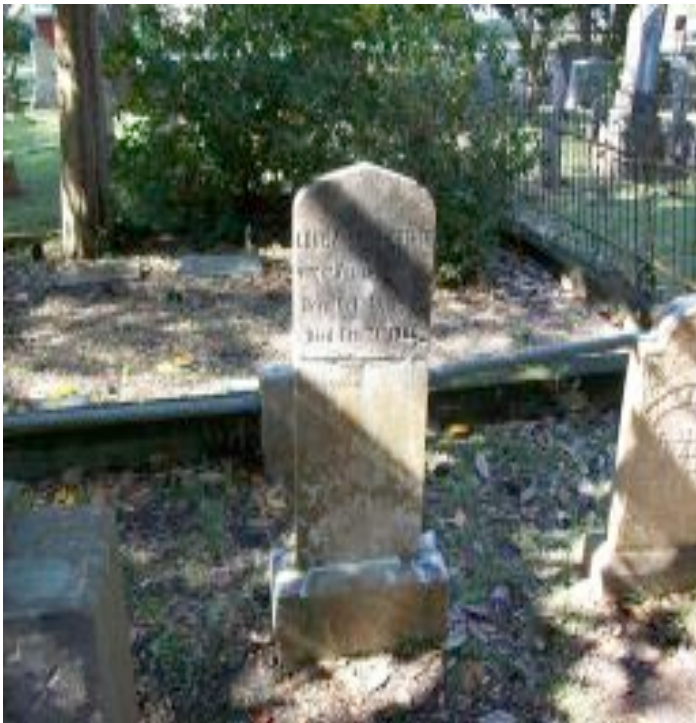
11. Lousia Smith Doshier St. George stone Section NR, A-3: Epoxied head stone back together (Homework left from Eric Kozan school in May, 2009).

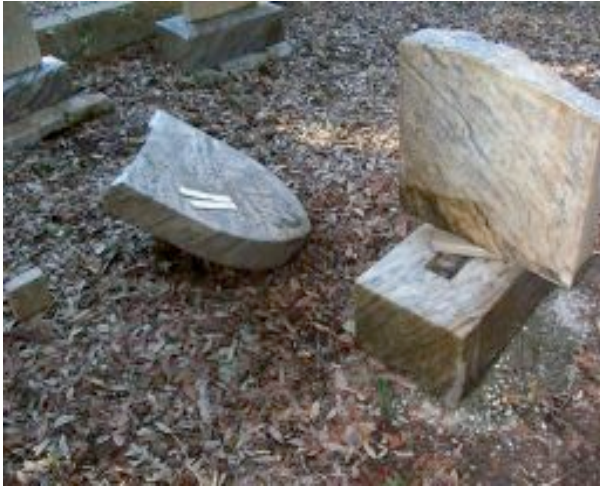
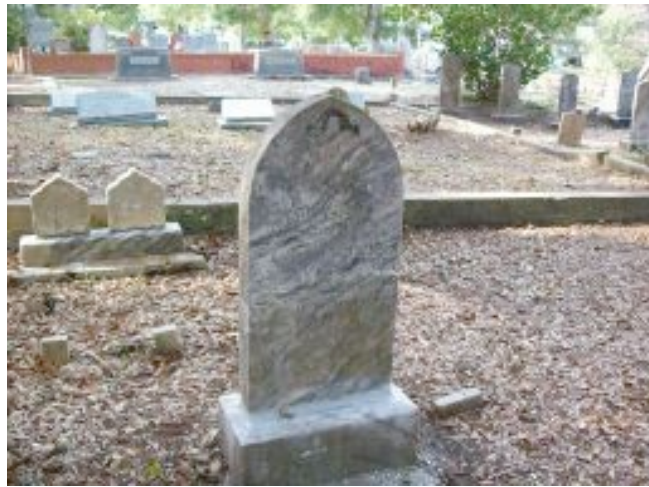
1. John Julius Doshier Stone – Quadrant BN Location G6 - Stone top broken off, base was not adhered to foundation so that grave stone tipped over. Cleaned where stones are to be joined together. Used SHS cemetery cement the first time to join bottom stone to foundation. It did not work. Clean foundation again. Used epoxy for the second time to get bottom stone to adhere to foundation. Had help from Scott and Robert Jones to get top piece in place. Epoxied top piece to bottom piece.

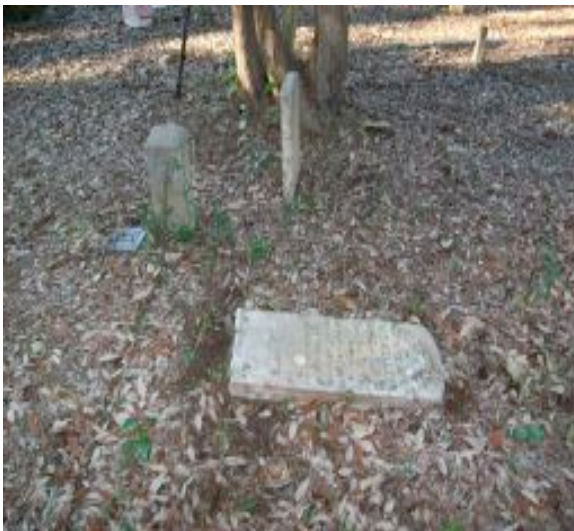
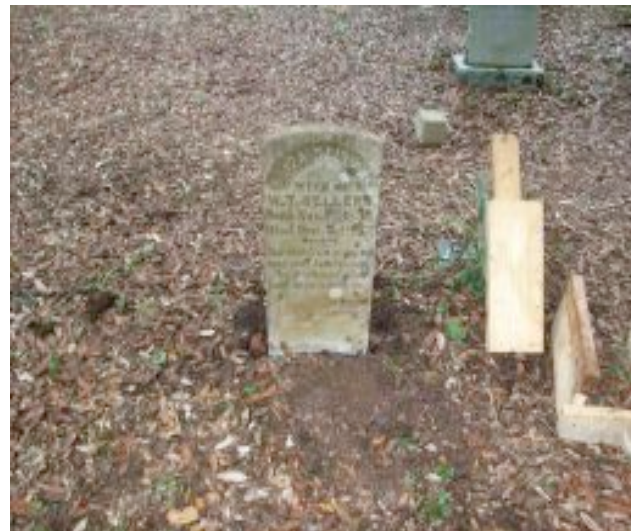
2. Eliza Sellers Stone – Quadrant BN Location G6 – Grave Stone down on ground flat on back. Found foundation in ground. Cleaned both stone and foundation where joined together. Epoxied grave stone upright to foundation.

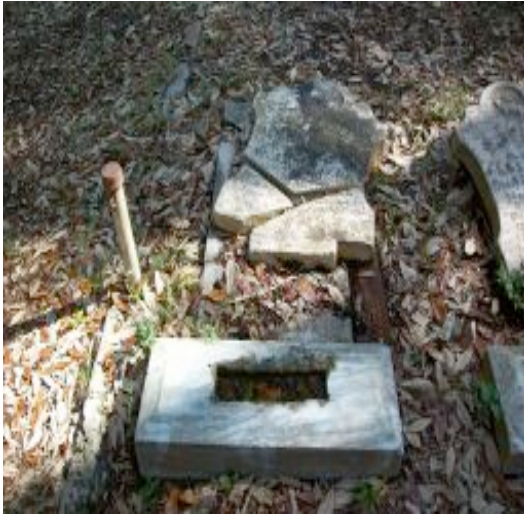
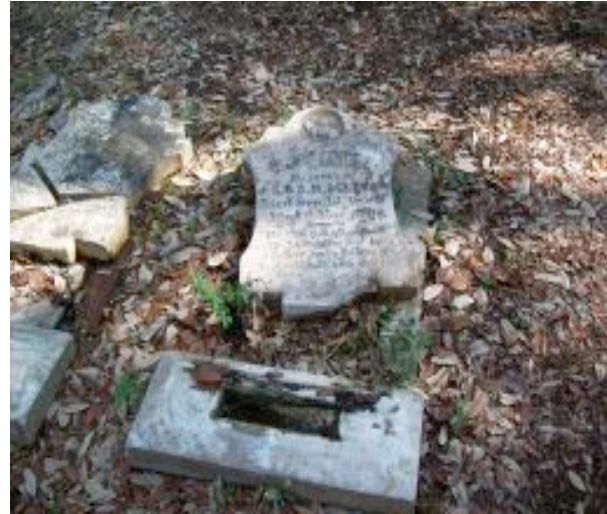
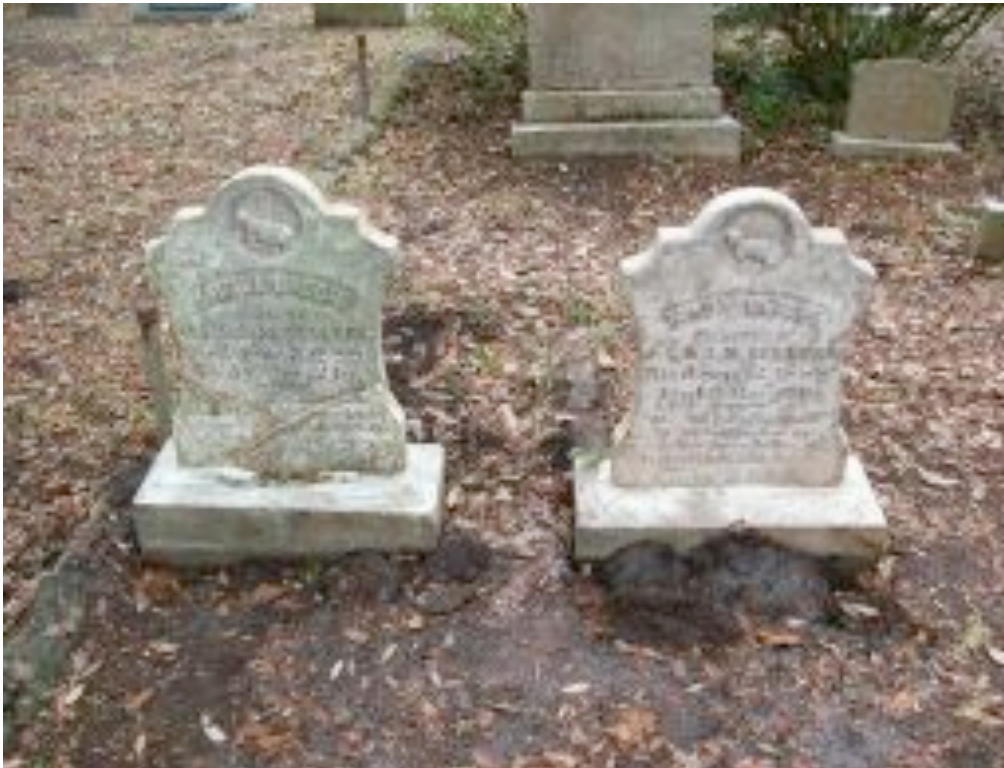
3. Sellers' Twins stones – Little Buddie - Mary Ceicel - Quadrant BN, Location 16 – Grave stones down flat on ground. Base of grave stones broken and left in main foundation. Little Buddie stone was broke into 3 sections. Leveled foundation stones. Clean up the slot where the gravestone fits in. Cleaned where stones were to be joined together Epoxied the stones back into foundation and into 1 piece. Cleaned the stone's faces.

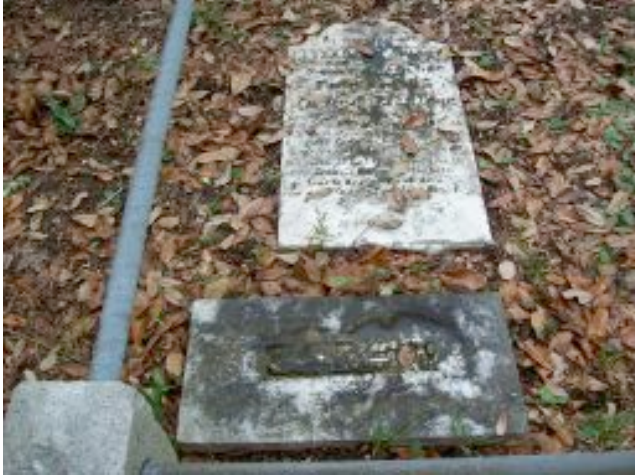
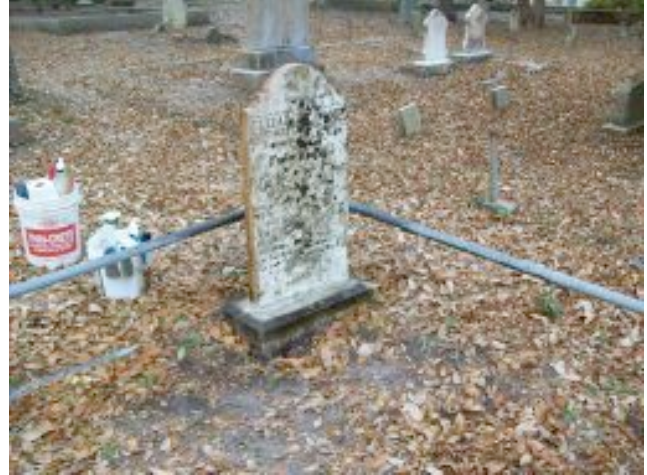
4. Elizabeth Ruark stone – Quadrant BM, Location F7 – Grave stone down flat on ground, stone key left in foundation stone. Dug out the keystone. Leveled the foundation stone. Cleaned out the slot in foundation stone. Cleaned where stones are to be joined together. Epoxied the gravestone to the foundation stone twice. Cleaned the grave stone face.

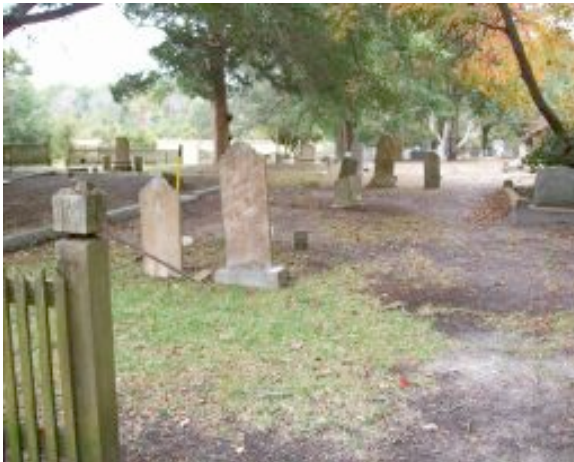
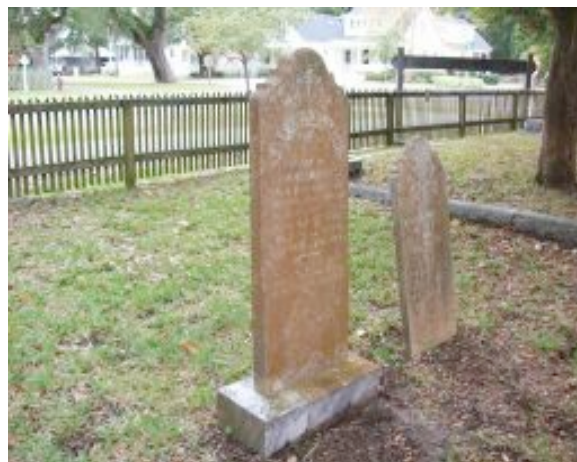
5. Ellen Clemmons Stone – Quadrant NR, Location F1 - Stone was leaning. Leveled stone using pebbles.

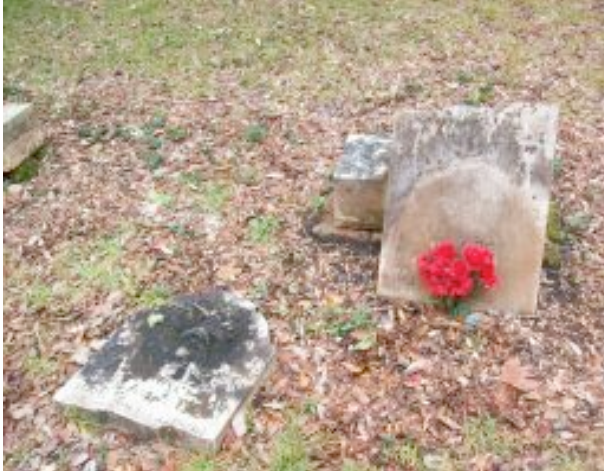
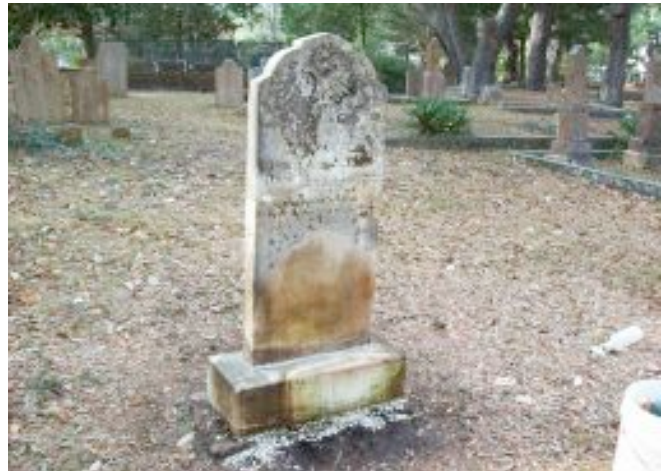
6. Olie Watts stone – Quadrant BM, Location D6 - Foundation stone not level, Gravestone broken into 2 pieces. Leveled foundation stone using pebbles. Cleaned where stones are to be joined together. Epoxied lower stone to foundation. Epoxied the top of stone to lower stone. Joe Loughlin helped with placement of the top stone. Cleaned the stone face. Replaced Flowers (not in photos).

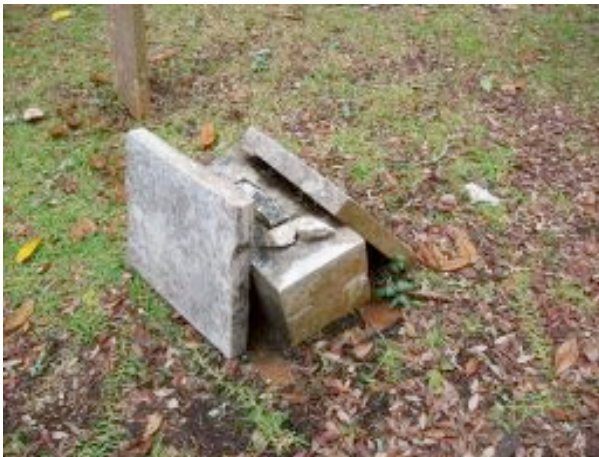
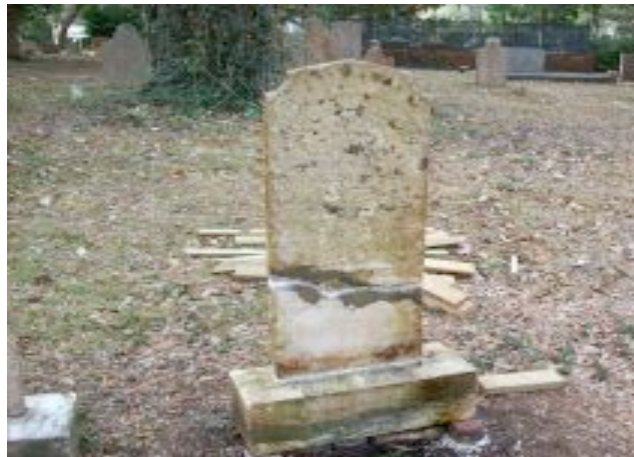
7. Charles V. Fullwood – Quadrant BM, Location E5 Foundation stone not level, Stone broken into 2 sections. Leveled foundation stone using pebbles. Cleaned where stones are to be joined together. Epoxied lower stone to foundation. Epoxied the top of stone to base. Cleaned the stone face. Replaced flowers (not in photos)
